RECOMMENDATIONS FOR HIGHWAY CONSTRUCTION, MAINTENANCE, AND SERVICE EQUIPMENT WARNING LIGHTS AND PAVEMENT DATA COLLECTION SYSTEM SAFETY

Report 3972-S
Project Number 7-3972
Research Project Title: Maintenance Vehicle Warning Light Systems
and Safety Evaluation of Pavement Data Collection Systems

Sponsored by the
Texas Department of Transportation

October 1998

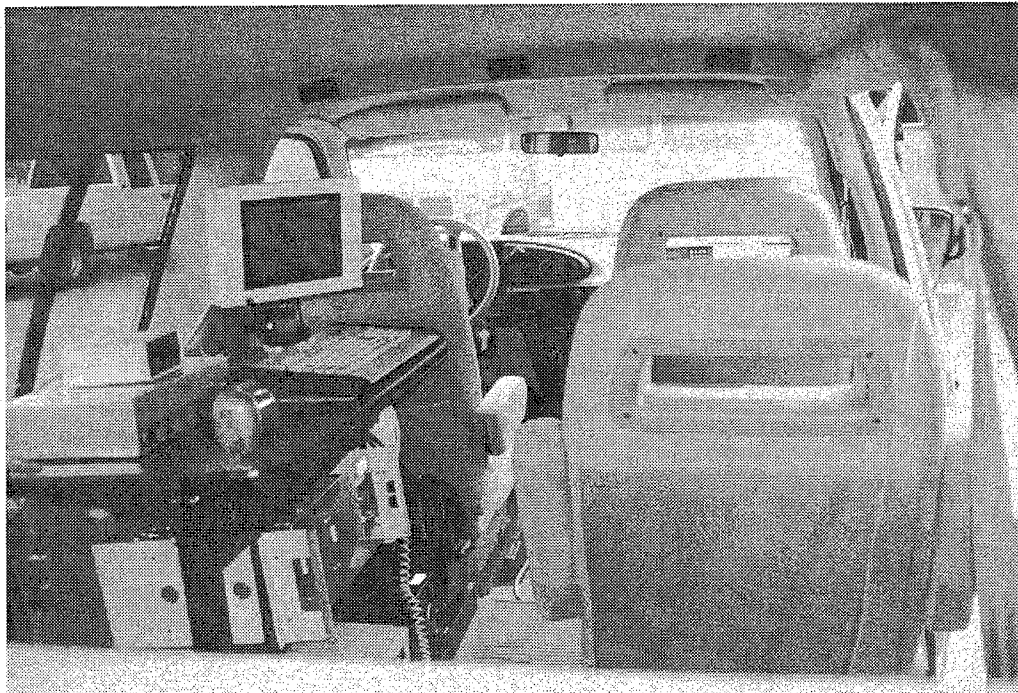
Figure 1 illustrates a case where researchers believe one of the mounting methods may be deficient. The monitor is secured to the table using a mounting bracket designed for home or office use. The mounting is secured to the monitor housing which is made of plastic. This plastic is not believed to be of sufficient strength to withstand high forces (such as during a sudden deceleration or rollover situation). The bracket could separate from the monitor in this situation, and the monitor could become a dangerous projectile.

Figure 1. Example of Potential Monitor Mounting Bracket Problem

1. Ensure that all equipment and instruments are fully secured. These items include tables and cabinets for mounting and setting equipment. When mounting brackets are bolted to pieces of equipment, consideration should be given to the structural integrity of that equipment housing. Bolts through plastic housing are likely to pull loose in the event of a crash and thus allow the equipment to fly through the vehicle cabin. This significantly increases the potential for bodily injury to data collection personnel.

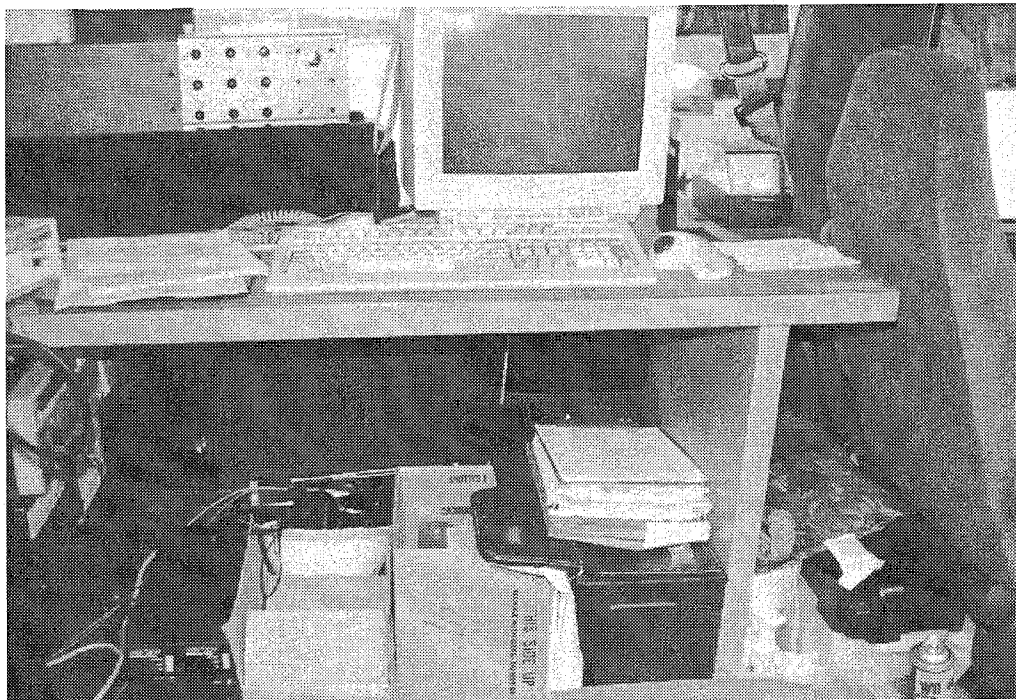
Figure 2 illustrates another case where a computer desk is being used for the electronic equipment and deficiencies are believed to exist in terms of how equipment is secured within the vehicle. Again, the computer monitor is strapped to brackets that are secured to the table using screws. This method of securing the monitor is sufficient for normal vehicle movements (forward or reverse) but may not be sufficient for movements or forces perpendicular to the monitor screen. For instance, the monitor might slip out and become a projectile in a side-impact or rollover situation.

Figure 2. Example of Unsecured Equipment in Research Vehicle

Researchers also note that there are unsecured items (equipment, papers, aerosol can, etc.) under the table and between the table and the driver seat in Figure 2. Under normal driving conditions, this does not pose any significant safety threat. However, under extreme conditions, loose items may be potentially dangerous to the vehicle occupants. According to basic laws of dynamics, the force with which a moving object hits something in its path is dependent on the velocity at the time of impact and the mass of the object. Thus, a small object moving at a high velocity can be as dangerous as a larger object moving slowly.

The top-left corner of Figure 2 shows a section of mounting boom for the ground penetrating radar when it is transported inside a vehicle. It is 1.8 m (6 ft) long and has a significant weight. The boom is stored in the vehicle in a full length U-bracket. This bracket is secured to one side of the vehicle and has plates at the two ends to prevent the boom from sliding out. However, the center-of-mass of the boom is located at a point that is higher than the top edges of the U-bracket. In addition, the radar boom is not secured to the bracket. Under normal driving conditions, the weight of the boom will keep it inside the bracket. However, there is a possibility of the boom falling out if the vehicle traverses a large bump, or if the vehicle is involved in a rollover situation. Thus, researchers strongly recommend that a metal locking bracket or other sort of mechanism be used for properly securing the boom to the vehicle.
